DESCRIPTION	DATE
Contactor	Sept. 25, 2003

Identification: SF-20

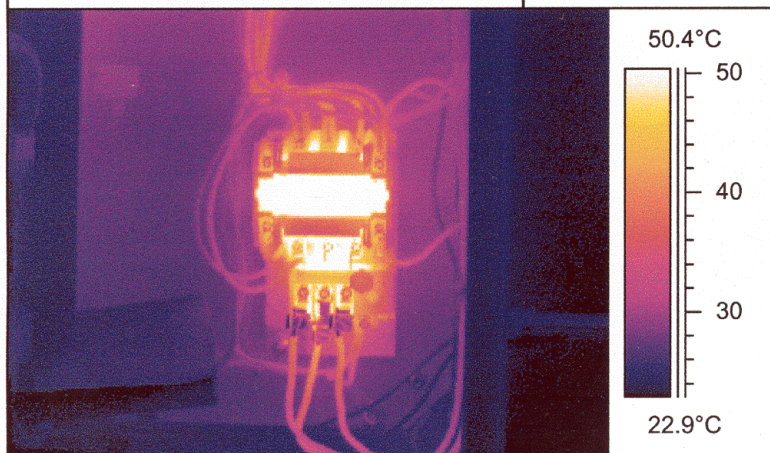
INFRARED IMAGE

IR information	Value
Date of creation	9/25/03
Object parameter	Value
Ambient temperature	22.0°C

Current Measured at Time of Inspection
5 A, 5 A, 5 A

DESCRIPTION:
<p>An InfraRed image of a contactor located inside SF-20 control panel, located in the B1 mechanical room. <u>No heat related problems were noted.</u></p> <p>Our visual inspection noted a broken coil retaining clip (at green arrow in photo).</p> <p>See IR information chart above for maximum temperature located inside the area box (AR01).</p>
