DESCRIPTION	DATE
Fuses	Nov. 21, 2003

Identification: CV 087, Section A-70

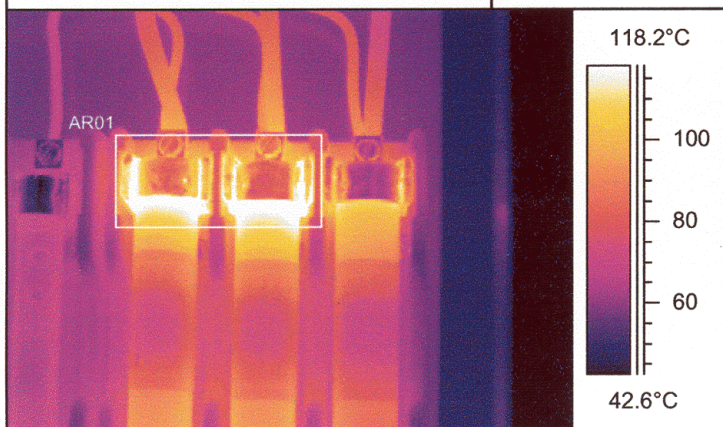
IR information	Value
Date of creation	11/21/01
Object parameter	Value
Ambient temperature	22.0°C
Label	Value
AR01 : max	146.6°C

An InfraRed image of fuses located inside the CV 087 panel; identified as the main fuses. Heating was noted on the top-middle/ left fuse clip connections (red arrow in photo). See IR information chart above for maximum temperature inside area box.  
*An Immediate Action Report was issued for this anomaly at the time of the inspection.*

Check the connection components for heat damage. Replace if required.  
Clean the fuse and fuse clips. Ensure the fuse clip tightness as per the manufacturer's specifications.  
Re-inspect the unit after the repairs are completed.
