VIBRATION CONDITION CHECK

Unit Designation: 100 H.P. Compressor

Date: February 7, 2004

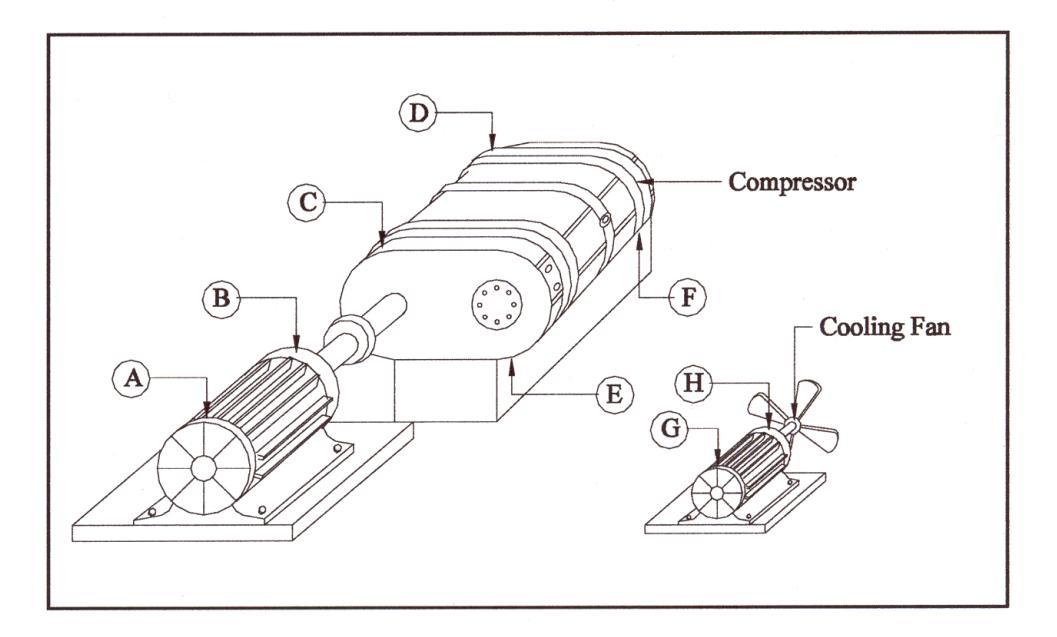
The overall vibration levels measured on the compressor and motor are within acceptable limits, however, the cooling fan motor is vibrating excessively. The cooling fan is severely unbalanced, which is the primary source of the vibration.

The compressor bearings appear to be in good mechanical condition, however, the drive end motor bearing is showing moderate to advanced wear. The cooling fan motor bearings are in good condition as well.

The compressor base is not isolated from the floor.

- 1.) Shop balance the cooling fan and motor, as a unit.
- 2.) Periodically monitor the condition of the motor bearings. Replace the drive end motor bearing when convenient.
- 3.) Install vibration isolation pads under the compressor base frame.
